DEVELOPMENT AND TESTING OF A COMPLETELY PASSIVE, AIR SUSPENDED, AIR PROPELLED PERSONAL RAPID TRANSIT VEHICLE;

APRIL, 1973

FINAL REPORT.

7. Author(s) Charles H. Smoot et al	8. Performing Organization Report No. DOT-TSC-UMTA-73-1	
9. Performing Organization Name and Address Uniflo Systems Company 7401 Washington Avenue South Minneapolis, Minnesota 55435	10. Work Unit No. UM306/R3722	11. Contract or Grant No. DOT-TSC-367

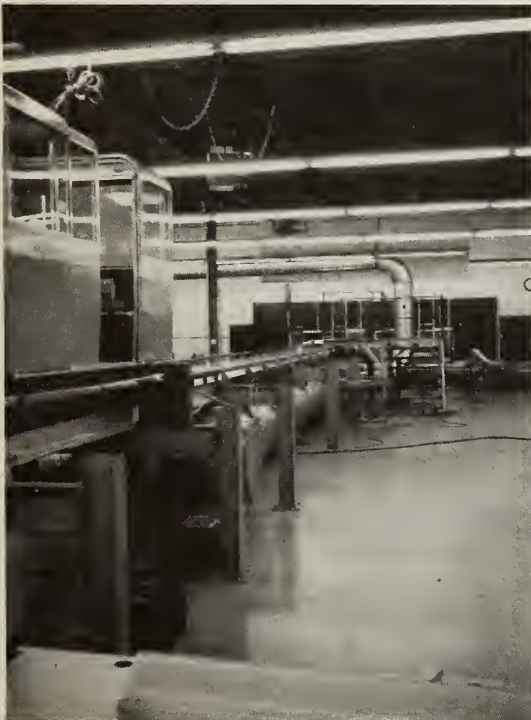
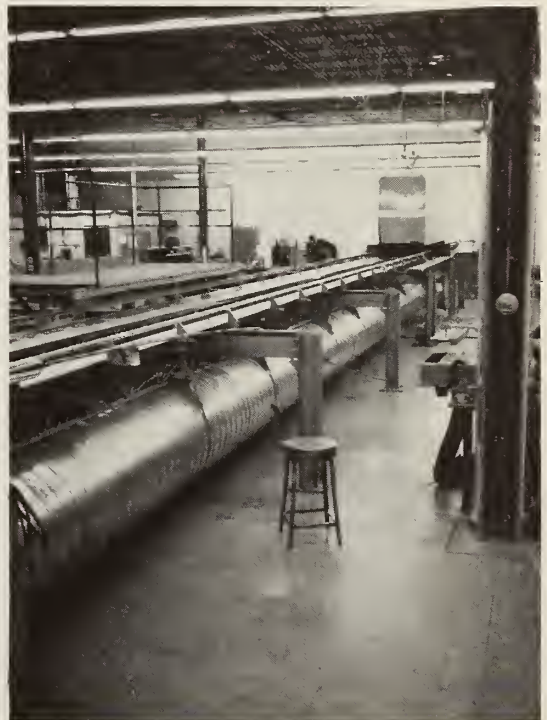
Figure 1-1. Test Facility Guideway from each end.

The facility was laid out so that the vehicle could be tested for acceleration, dynamic braking, and emergency braking.

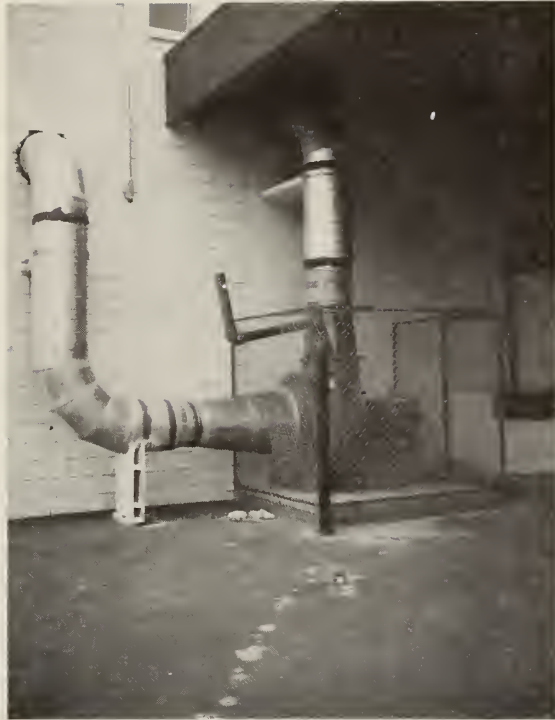
Figure 1-4. 150 HP Blower and Motor Installation

From the blower to the guideway, 22" diameter double-wall tubing carried the air. The inner wall of the tubing was perforated, and the gap was filled with fiber glass. This type of construction reduced the sound level of the blower. Installed in the tube was an orifice plate of 11" diameter, which measured the air flow. Unfortunately, the orifice plate caused a pressure drop of 8 to 10 inches of water at running conditions. Because of this drop, the variable inlet vanes were opened slightly, and the blower would surge at low flows (levitation only).

Figure 1-4 shows a photograph of the blower installation.

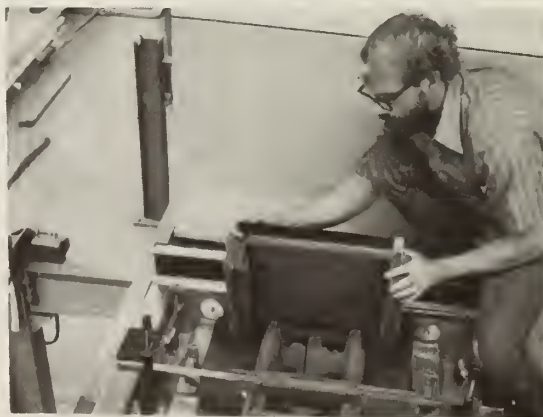
Figure 2-2. Acoustical Baffling

Acoustical baffles were installed in the vehicle above the turbine exhaust ports as shown in Figure 2-2. Sound absorption is obtained with a lead-foam sandwich. This was built up using 1/4" urethane foam with adhesive on both sides—1 lb./ft.² lead sheet, and 3/4" urethane foam with adhesive on one side. The installation of this baffling had no measurable affect on sound levels outside the vehicle, and only 1 to 2 DBA inside the vehicle.

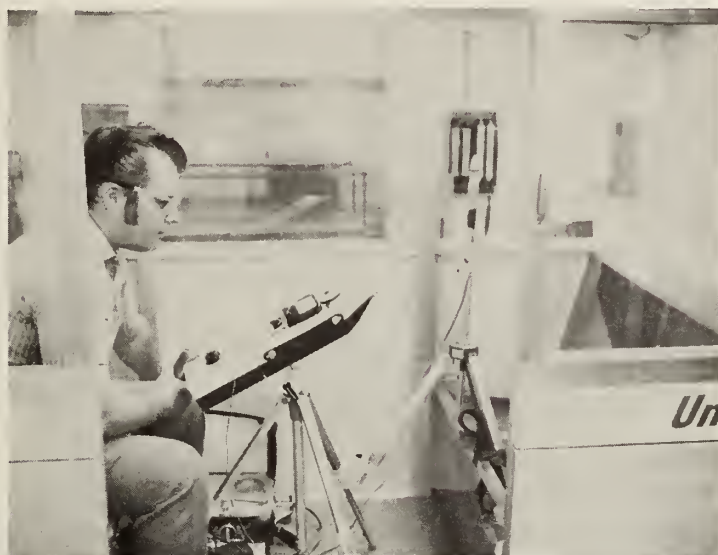
Figure 3-2. Sound equipment set-up in the vehicle.

Then the recorder and microphone were installed in the vehicle with an operator, and the runs (a through d) repeated and the noise levels in the vehicle recorded. See Figure 3-2 for the equipment set-up in the vehicle.

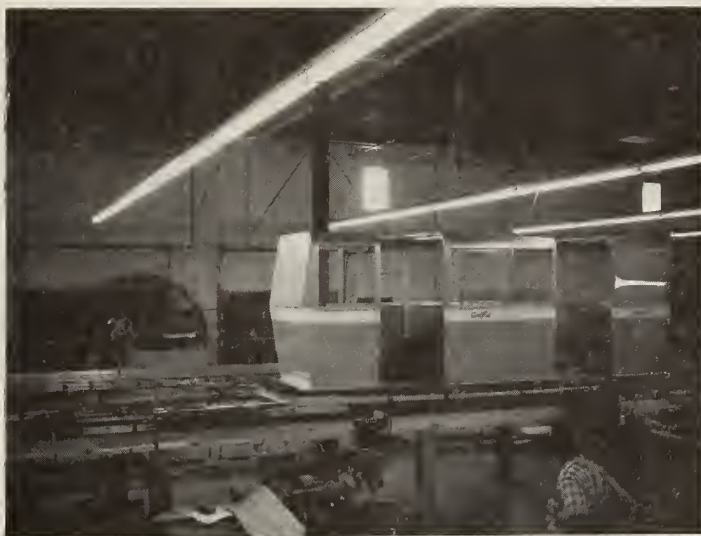
Figure 6-1. Vehicle entering arresting mechanism.

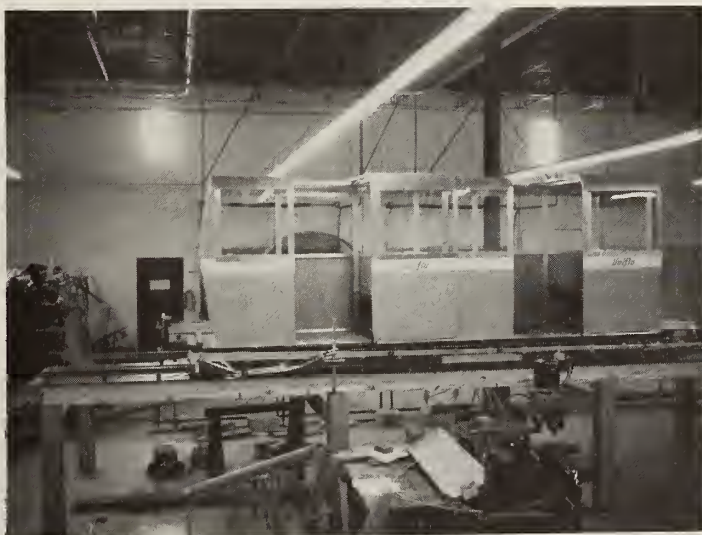
Figure 6-2. Vehicle with arresting mechanism fully extended.

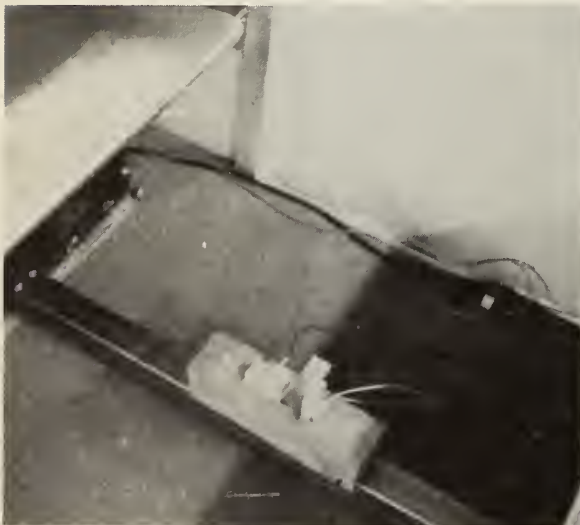
Figure 6-3. Accelerometer Installation.

The accelerometers were attached to a wood block, and then to a metal bar. This bar was attached to the main support frame of the superstructure. Figure 6-3 shows the installation. The tachometer was installed in the vehicle, and is shown on Figure 6-4. The position detector is shown in Figure 6-5. The pad pressure transducer was installed in the vehicle. All the vehicle mounted transducers were routed to an interconnection and signal conditioning instrument.
